Confidential Inspection Report

FILE/DATE/TIME	1/21/23.
CLIENT NAME	John Smith.
LOCATION	1234 Any Street.
WEATHER/SOIL	Weather conditions during the inspection: Dry 61 F.

MAIN ENTRY DESCRIPTION	Faces: North. Stucco over conventional framing. Ranch style 2 Bed & Bath down and 1 Bed & Bath up.
FOUNDATION	Foundation types: Perimeter concrete.

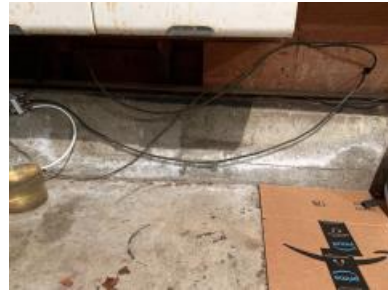
102 EXTERIOR

The exterior foundation is covered with Stucco.

Some foundation is visible in the garage.

The second floor is framed with post and beam structure.

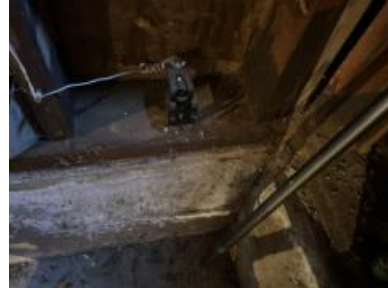
109 COLUMN(S)
110 FLOOR JOIST(S)
112 SUBFLOOR

The sill plates in the garage are present and in fair condition.

Joists are visible in the garage. They appear sound with some minor water stains.

The underside of the subfloor is visible in the garage. It appears sound but has some evidence of a leak.

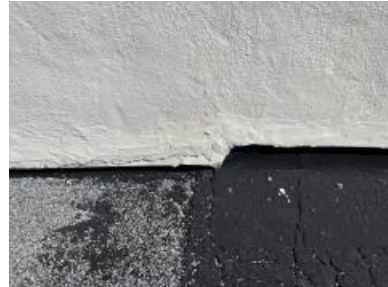
302 ROOF COVERING(S) Materials: The roof is a tar and gravel roof.

303 ROOF LAYER(S) There are an undetermined number of layers. The Tar is beginning to deteriorate. I recommend contacting a roofer to further evaluate.

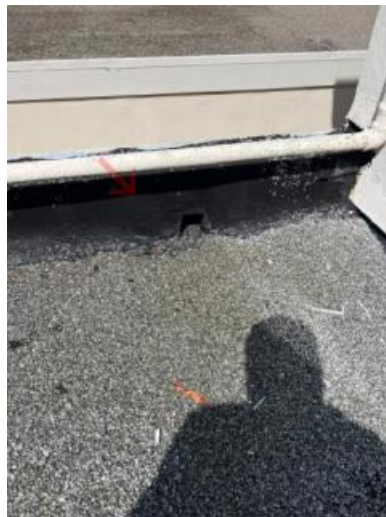
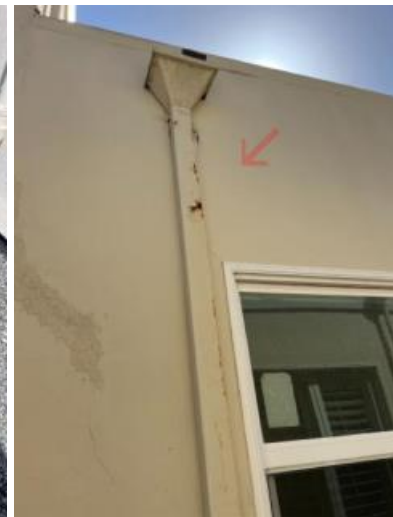
304 ROOF DRAINAGE Materials: Metal scuppers and metal downspouts. Downspout is showing signs of age.

316 COMMENTS The tar and gravel roof is at the end of its life. There is evidence that it has been maintained with patch repairs. The flashings are rusting and the wall returns are showing signs of UV damage.

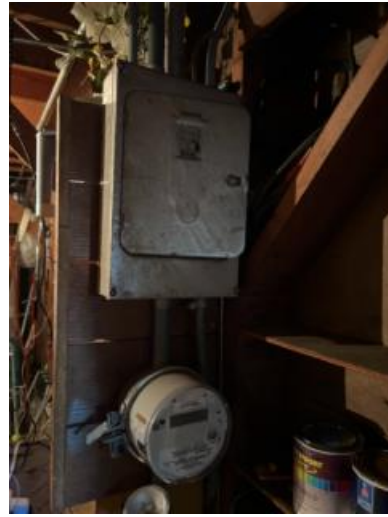
- 601 SERVICE TYPE** Overhead.
- 602 MAIN PANEL** Located in the garage.

603 SERVICE RATING	120/240 volt system, rated at 80 Amperes.
604 SERVICE WIRING		Materials: copper observed in the main panel.
605 CIRCUIT WIRING		Materials: copper observed in the main panel.
606 DISCONNECT TYPE		Fuses.

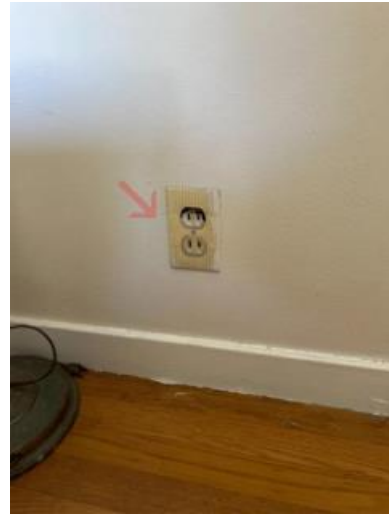
624 DOOR BELL	The door bell functions when the button is operated.
625 SWITCHES	The accessible switches are functional.
626 UNGROUNDED RECEPTACLE(S)	[FE] There are electrical receptacles in the interior rooms are the "two-prong type", which is common practice for structure of this age. We recommend a full evaluation of the electrical system by an appropriate professional in the appropriate trade prior to upgrading the receptacles to the "three prong type".

The accessible receptacles are functional and GFCI protected.

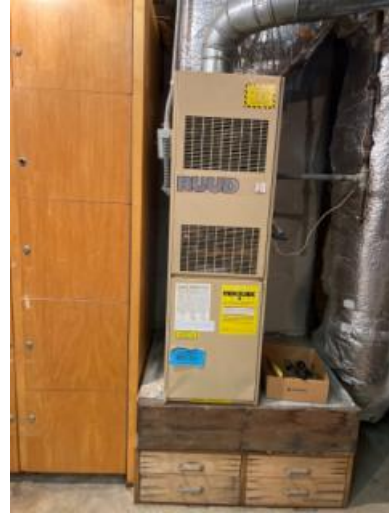
701 LOCATION(S) The unit is located in the garage.

Ruud.

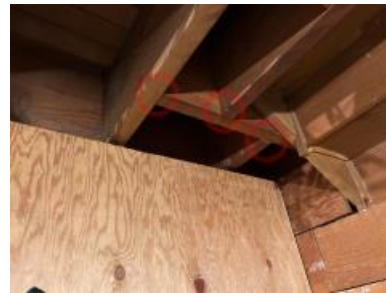
902 WALL(S)/CEILING(S) Materials: drywall. Framing in the garage does not meet current code. I recommend contacting a contractor to retrofit hangers and miscellaneous framing connectors.
